The Safety Network/ Le Réseau-Sécurité

Issue 4 2019

What municipalities and road safety stakeholders need to know about snow clearing around road-rail level crossings: Highlights from a recent Transportation Safety Board (TSB) investigation (2018)

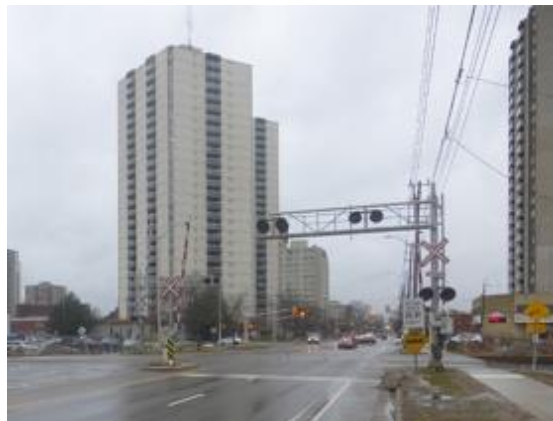
On the 9th of January 2018, at about 0940 am, a Canadian National freight train, while proceeding east on the Dundas Subdivision, approached the Colborne Street public crossing in London, Ontario. The crossing was equipped with flashing light signals, a bell, and gates.

Colborne Street public crossing, looking north (Source: TSB)

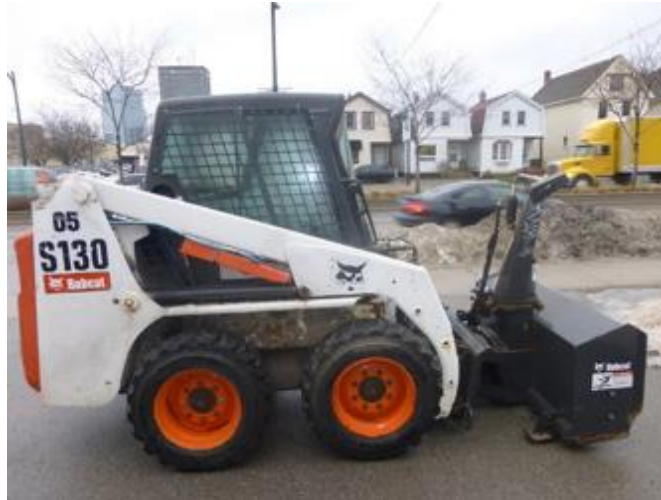
Bobcat S130 skid-steer loader equipped with a blower (Source: TSB)

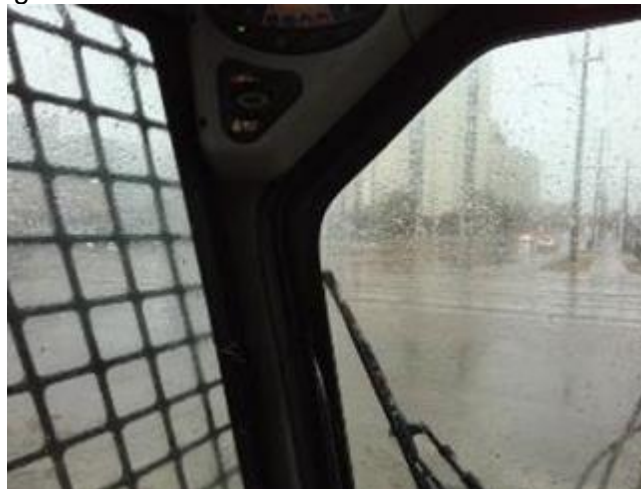
The collision re-enactment found that the operator's view from the cab of the snowplow was restricted. The front-left cab frame pillar obstructed the sightlines to the crossing lights and gates in the northwest quadrant when the snowplow was on the crossing. As well, the screening on the side windows hindered the view along the tracks. The restricted sightline further reduced the likelihood of the operator detecting the activated crossing warning system or the oncoming train.

Photo taken from a driver's seated eye position in the snowplow showing the view toward the northwest quadrant of the crossing when the snowplow was positioned adjacent to the southeast quadrant crossing warning system mast (the location of the snowplow when the gates began to descend) (Source: TSB)

Following the collision, the City of London required snowplow operators employed by its sidewalk snow-clearing contractors to participate in a City-led review of safe operating practices at railway crossings. Guidance documents on clearing snow at crossings were distributed to snowplow operators at this review session.

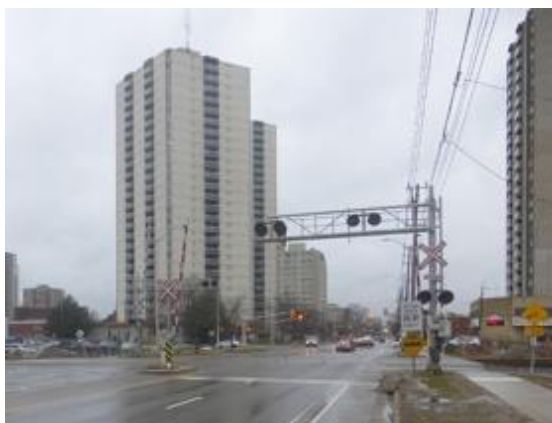
Passage à niveau public de la rue Colborne (vue vers le nord) (Source : BST)

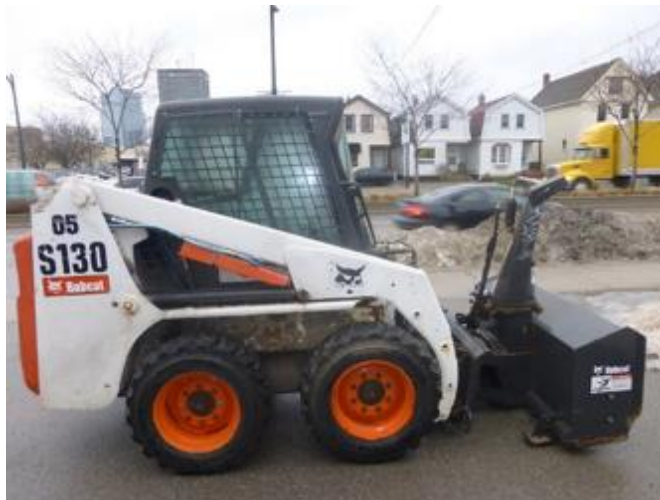
*Chargeur compact à direction à glissement muni d'un chasse-neige
Bobcat S130 (Source : BST)*

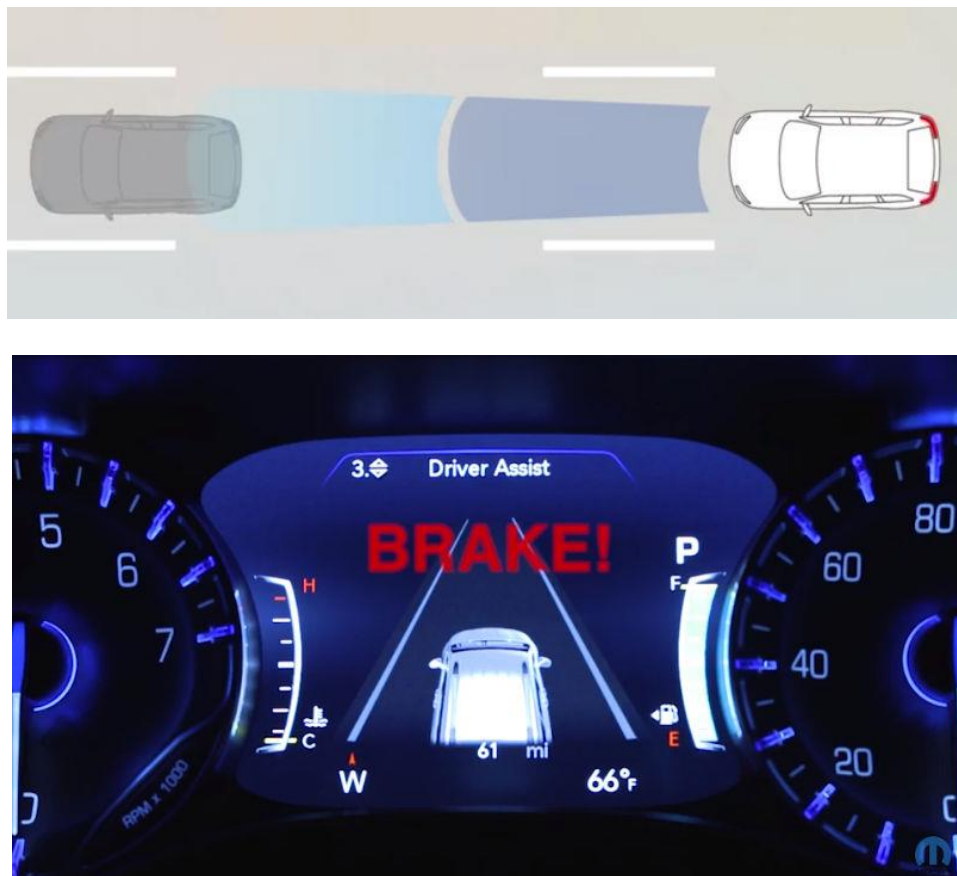
Figure 1. Operation of Forward Collision Warning System

Suddenly, the driver heard an alert issued by the vehicle's Forward Collision Warning (FCW) system and became aware that the vehicle was undergoing heavy braking. He indicated that there was no vehicle or object in close proximity to the pickup, yet the braking was such as to bring his vehicle to a complete stop on the highway.

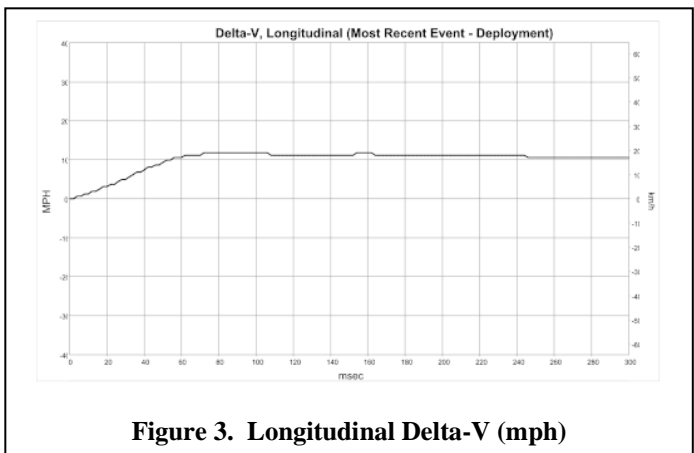
Figure 3. Longitudinal Delta-V (mph)

As the pickup truck was pushed forwards, the maximum longitudinal ΔV for the rear-end impact was noted as being 19 km/h (11.8 mph) with a duration 72 ms. There was no lateral component to the vehicle's change in velocity. The longitudinal crash pulse is shown in Figure 3.

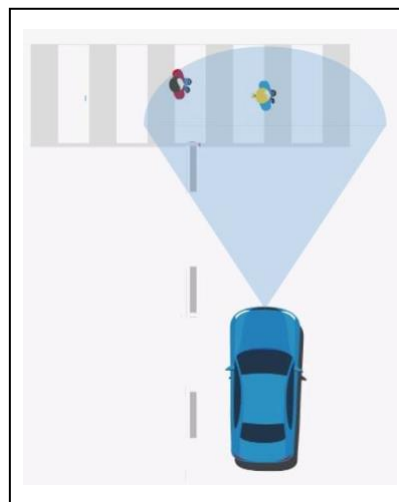
The image-processing system identifies external road users, typically pedestrians and cyclists, tracks their motion in real time, and predicts potential conflicts.

In particular, should the system determine that a pedestrian or cyclist is in the vehicle's path of travel, it will issue an alert to the vehicle driver and, if necessary, will apply the vehicle's brakes in an attempt to avoid impact.

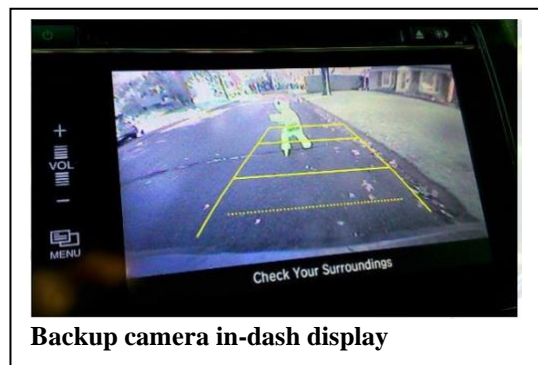
Backup camera in-dash display

As of May 2018, every new light-duty vehicle in Canada must be equipped with a Rear Visibility System (RVS). Commonly known as a backup camera, the system uses a video camera mounted at the rear of the vehicle that is activated automatically when the driver engages reverse gear.
